Repairing boats with Fibreglass Reinforced Plastics

a **Fibreglass**
Limited publication
in collaboration with
Tyler Boat Co. Ltd.

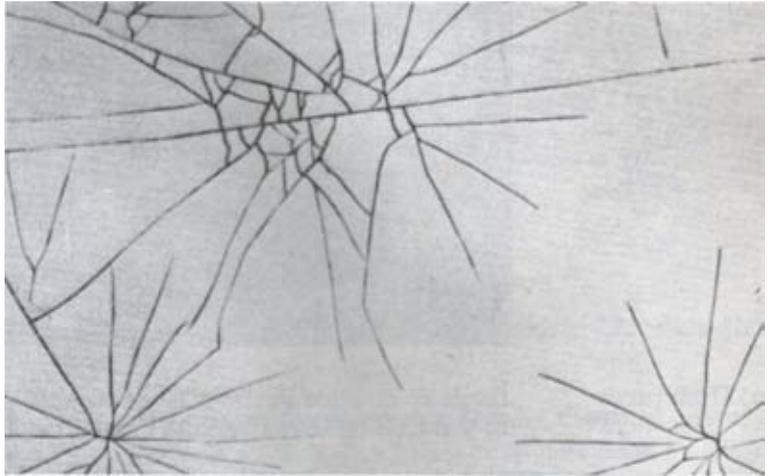
a) Hairline fractures

are cracks which are confined to the surface gel-coat and do not penetrate into the main laminate.

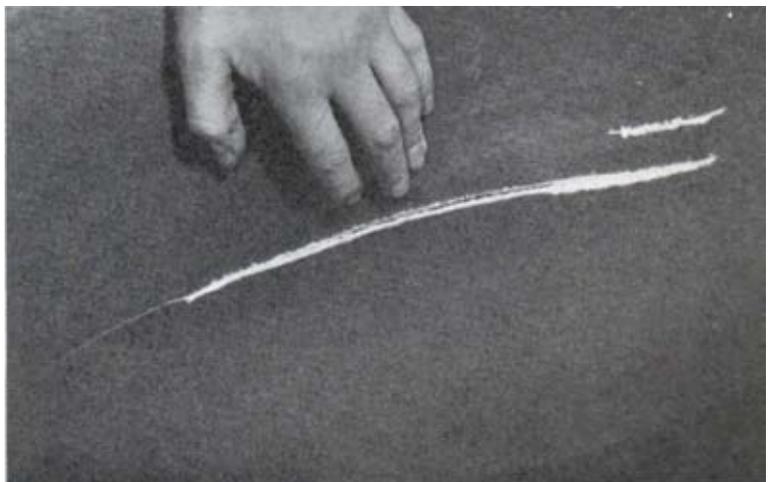
b) Grazes

are the result of abrasion rubbing off the gel-coat and exposing the Fibreglass reinforced laminate beneath.

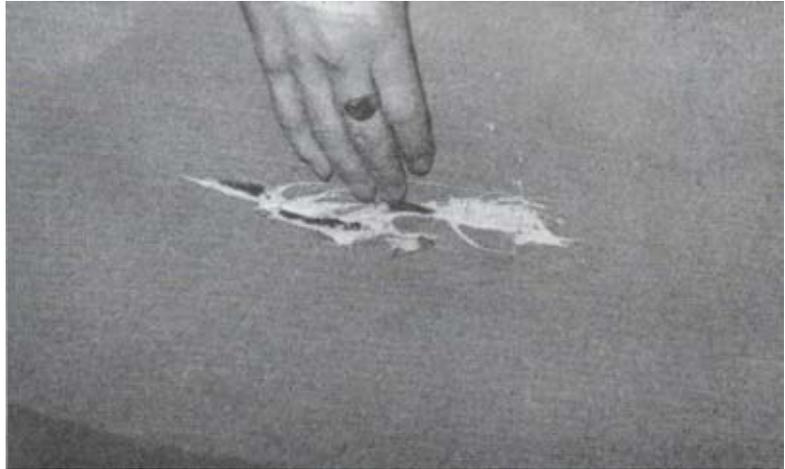
c) Impact fractures

are caused by a hard blow. In this case the laminate itself is crazed and damaged, although it is not completely penetrated.

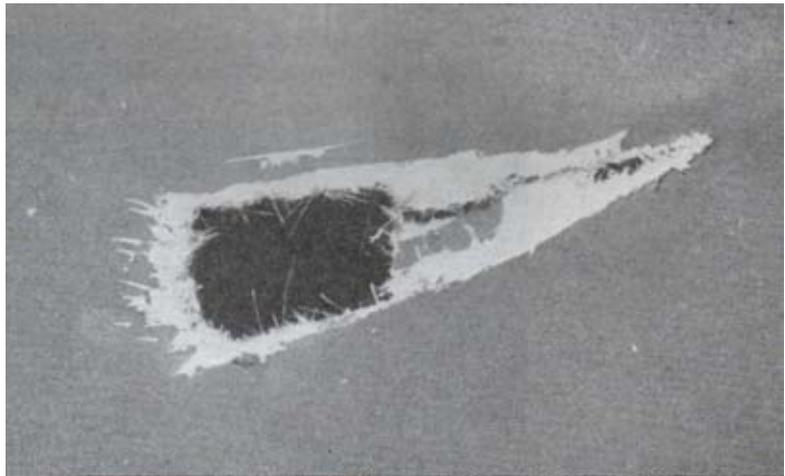
d) Punctures

result from a harder blow or impact with a pointed object and in this case there is a definite hole through the laminate.

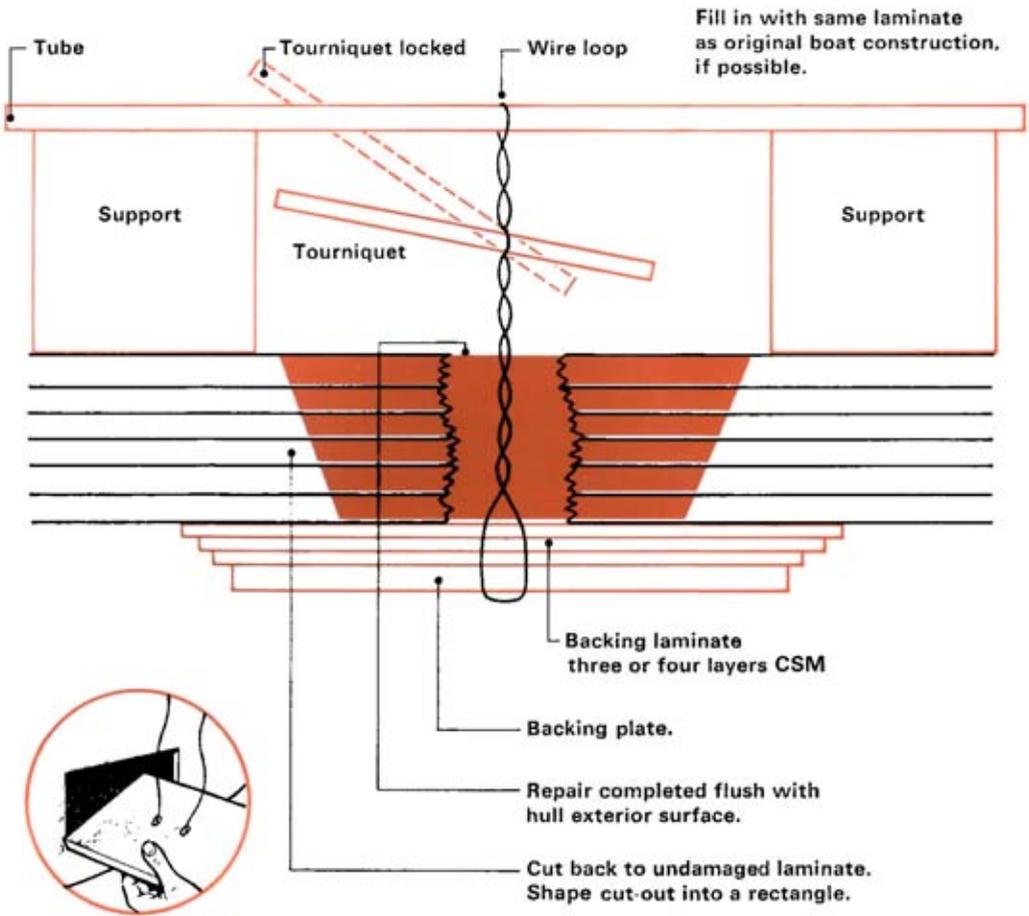
Repairing a blind panel

(a) In many boats it is impossible to reach the inner face of the hull in certain areas. When damage of the impact fracture or puncture type takes place in such a location a special repair technique has to be employed.

(b) The extent of the damage is first determined and a rectangular hole is then cut which removes any damaged laminate completely.

(c) A reverse facia plate is then produced. This can be plywood or hardboard, depending on the size of the cut-out. This plate is

also rectangular but is larger all round than the cut-out. It has to be passed through the cut-out and so the smaller dimension of this rectangle must be slightly smaller than the larger dimension of the cut-out. (See diagram.) Two small holes are drilled in the facia plate near to the centre.

(d) Three or four layers of $1\frac{1}{2}$ oz/ft² CSM are laid up on one face of the plate, stippling in activated resin then rolling to consolidate and remove air.

(e) A length of strong wire is passed through the two holes in the plate and through the laminate so that the ends project through the outer face of the laminate.

(f) The reverse facia plate and laminate are then passed through the cut-out and are pulled back into position so that the wet laminate is pressed hard into contact with the interior of the hull shell. Tension is applied to the wire to maintain this contact. An easy way to do this is to bridge the repair with a bar placed on stand-off blocks at each end. Fix the wire on a loop over this bar, then apply tension with a tourniquet.

(g) When the backing laminate has cured fully preferably overnight trim the wires back as close as possible to the laminate.

(h) Build up the repair with further layers as used in the hull construction until it is just below the hull exterior. Finish with a generous coat of resin.

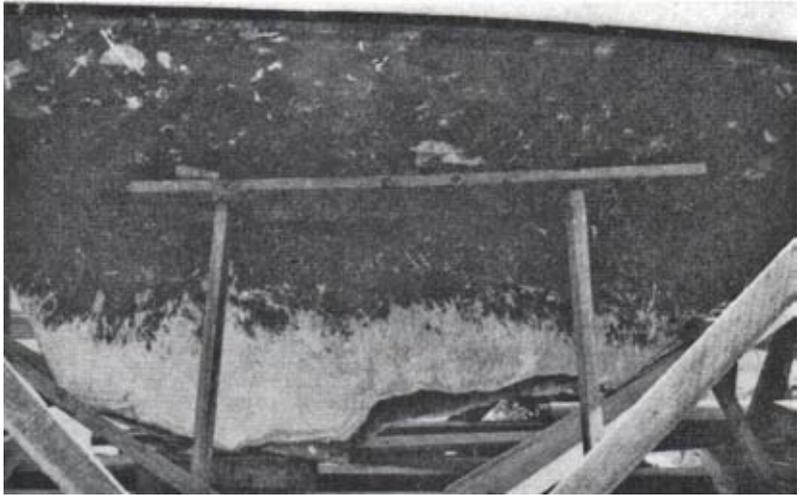
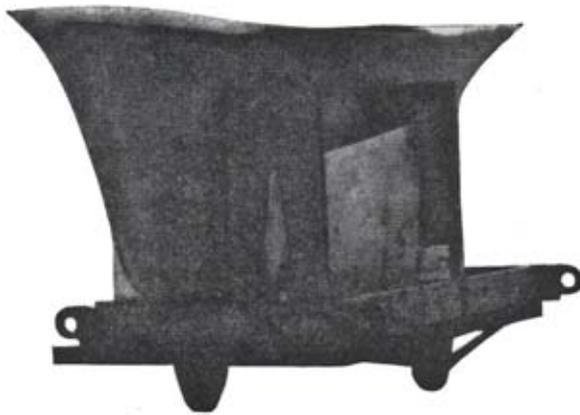
A repair example

During a storm in the West Indies, `Merlin' went aground on a reef and for 18 hours was pounded unmercifully. Once the storm had abated the yacht was refloated and sailed 3 miles to a safe anchorage. From there `Merlin', with full rig, was towed 40 miles back to base in a fairly rough beam sea. When describing the incident the owner remarked on the surprising stability of the damaged boat when in tow.

Inspection revealed that damage was mainly confined to the keel, but through continuous pounding on the reef this was indeed extensive. A large section has been worn and gouged away and, in consequence, most of the bonded-in ballast had been lost; of the original total of 2 tons 15 cwts under 1 ton remained. The owner suggests that it was this loss of ballast which made the boat light enough to float off the reef as the gale died down and it was probably the bonded-in petrol and water tanks which gave

sufficient buoyancy for this to happen. The rudder plate was also damaged beyond repair, but had remained in place and was used for steering the boat home.

Once the Insurance Company had given the go-ahead the Tyler Boat Co. manufactured a completely new keel section in Fibreglass Reinforced Plastics, bonding-in the ballast and tacking into their correct positions a new set of tanks. A new rudder was also moulded and this, together with the keel and all the necessary materials and equipment for attachment and a kit of tools, was shipped out to the West Indies within a few days.
